Yarralumla Shops Public Areas - Repairs and Maintenance Requirements

16 July 2018

Yarralumla Shops – Public Areas

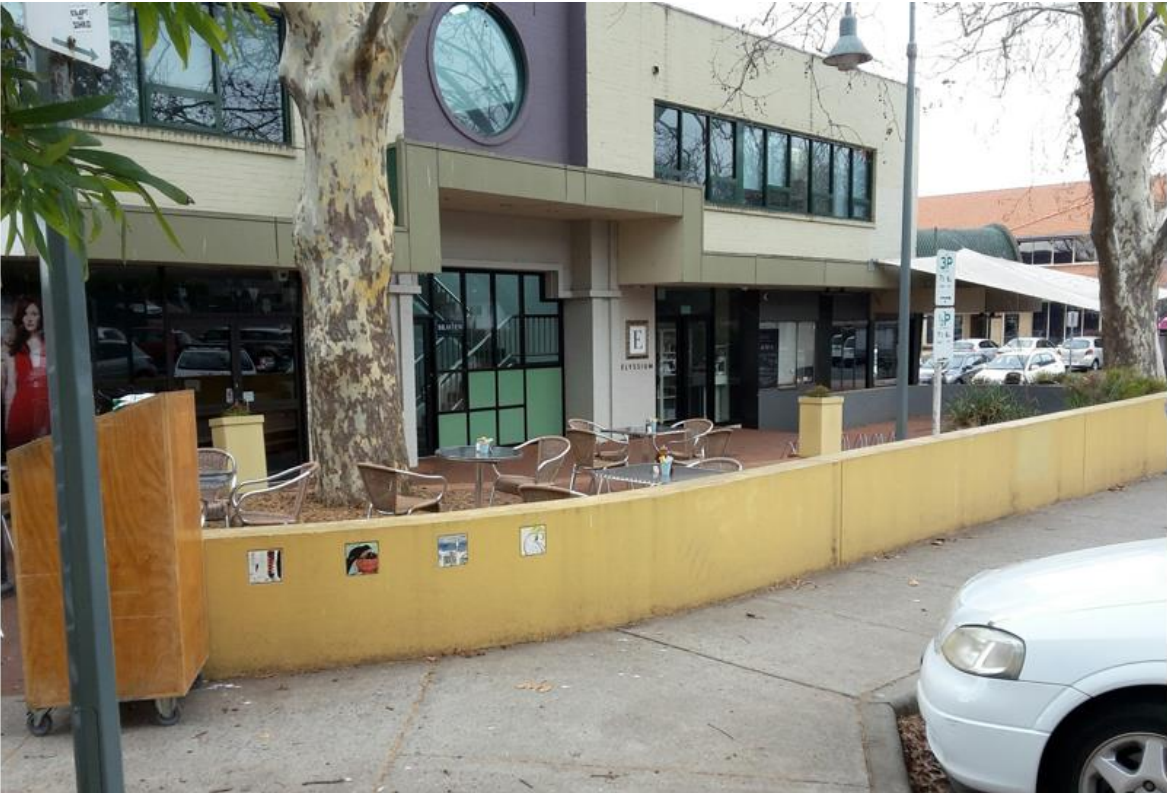
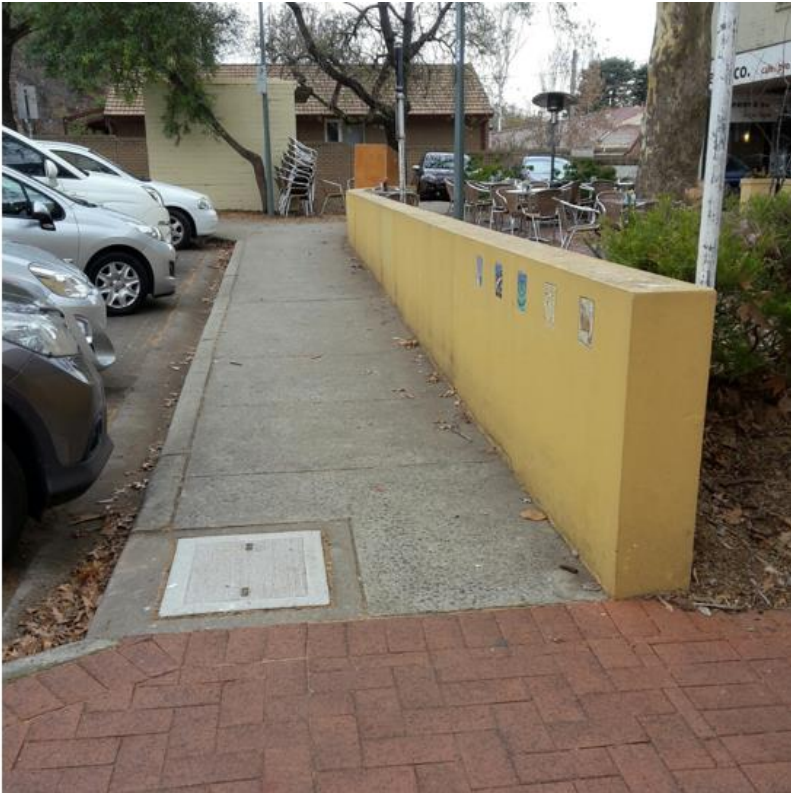
Hutchins Street Area

- The garden areas on Hutchins Street have had many shrubs removed but none replaced and two thirds of the area is bare, with the remaining plants now dying off.

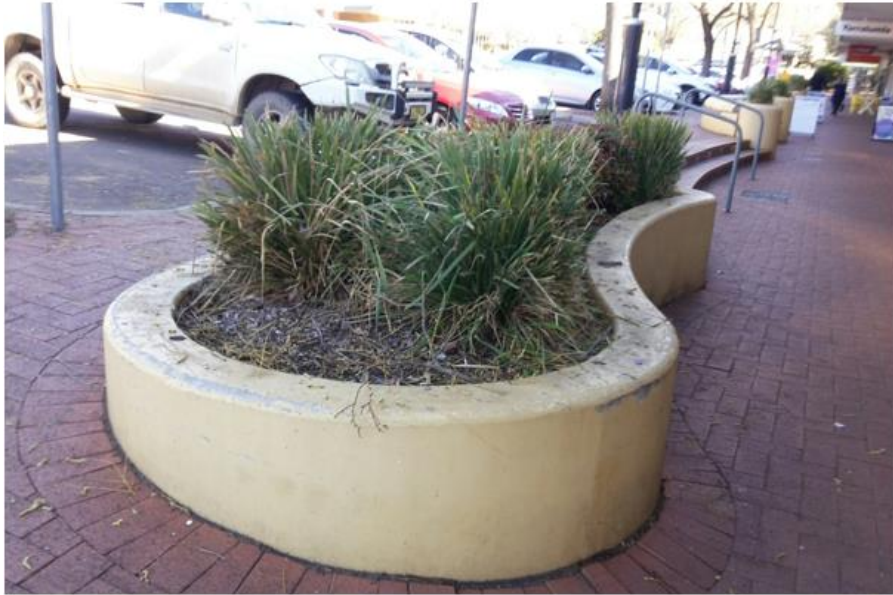
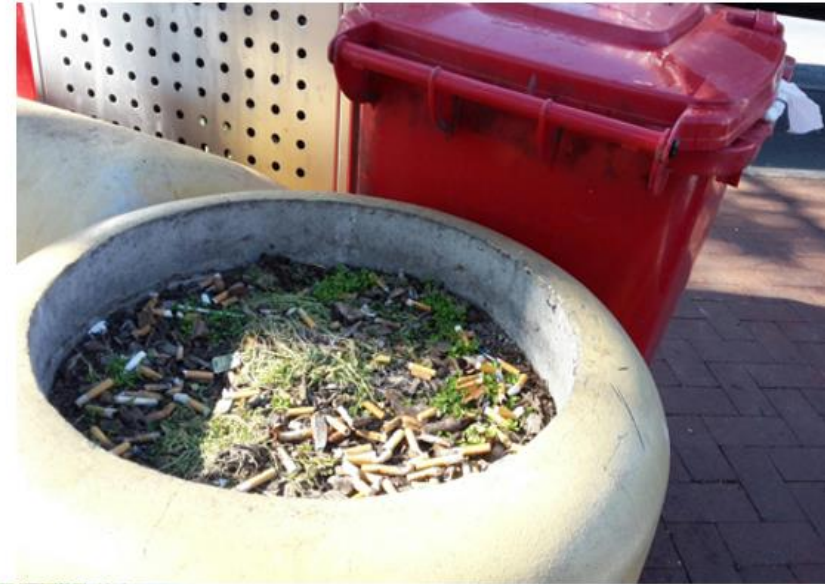
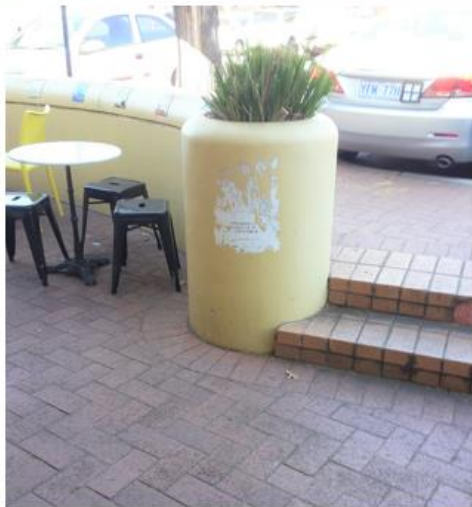
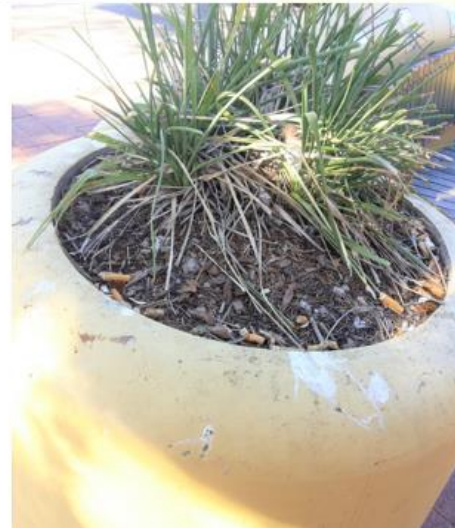
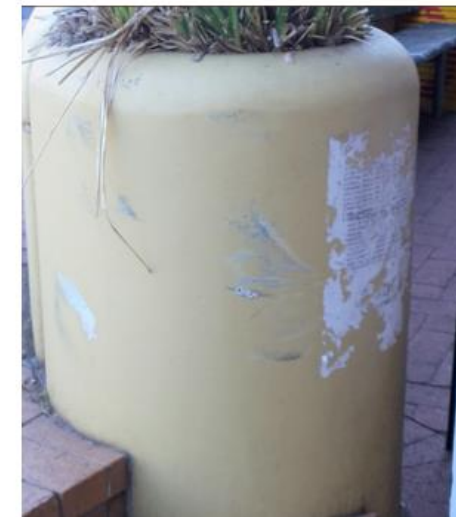
Concrete/brick alcoves chipped, flaking paint, dirty, old posters, gardens and plants not maintained - Bentham/Novar Street

- 2 of the 6 handrails on the sets of steps have been badly bent during ram raids of the shops
- All of the painted concrete and brick alcoves are badly chipped, the paint is old, flaking off and exceedingly dirty. Some areas have been subject to illegal bill posting.

- The Lomandra in the bench alcove planter beds and boxes have recently been topped. However, the beds still contain rubbish, the dead Lomandra plants need to be removed and replaced, and the preponderance of dead leaves need to be pruned and removed.

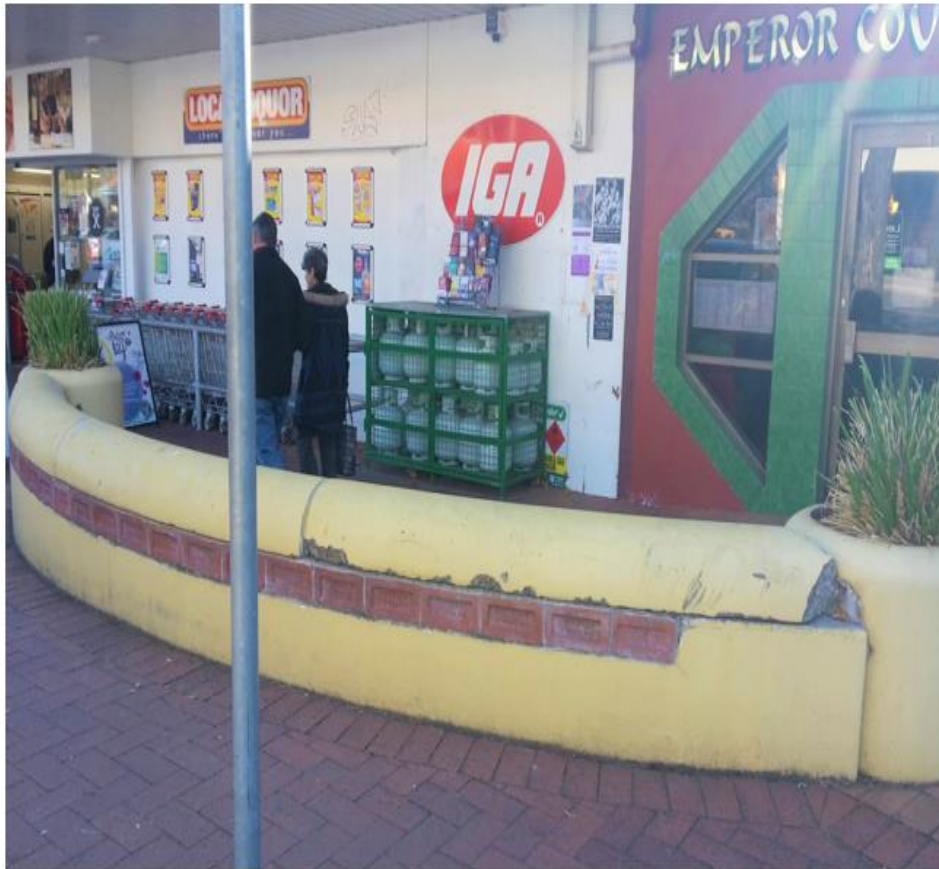
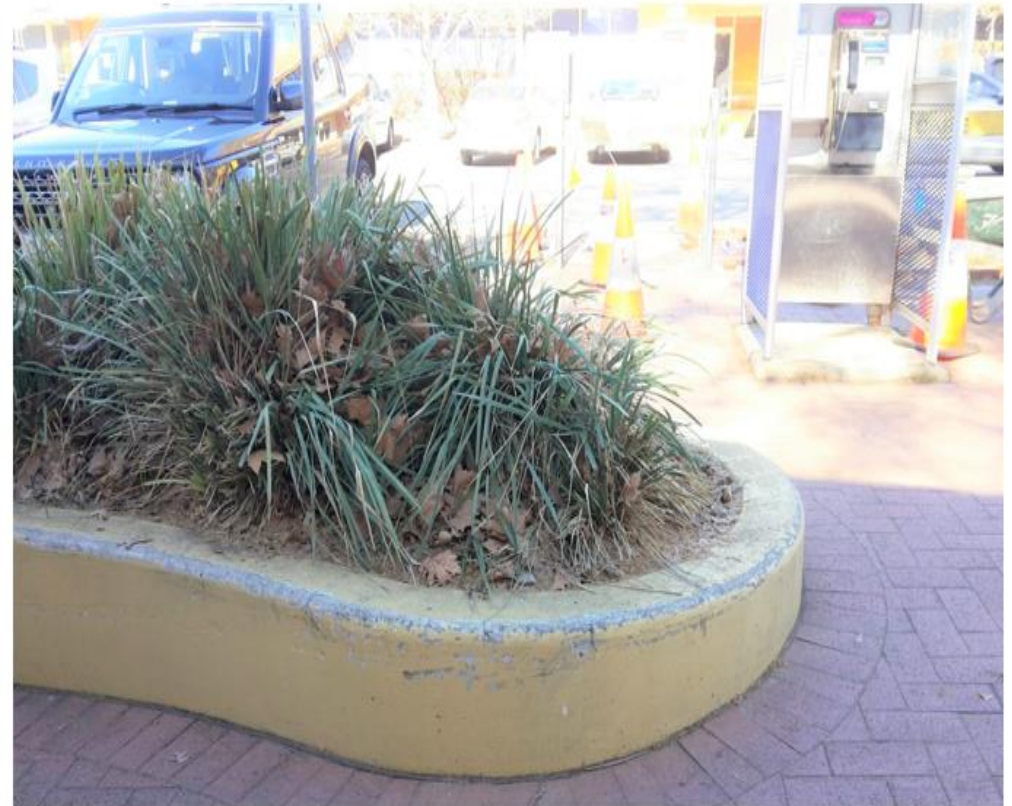
Concrete/brick alcove loose dangerous top section, damaged paintwork – Bentham Street

- The top section of the bench alcove wall, on the eastern side of the IGA, is completely loose, with a large chunk broken off, and poses a danger to the public. It was damaged in a ram raid.

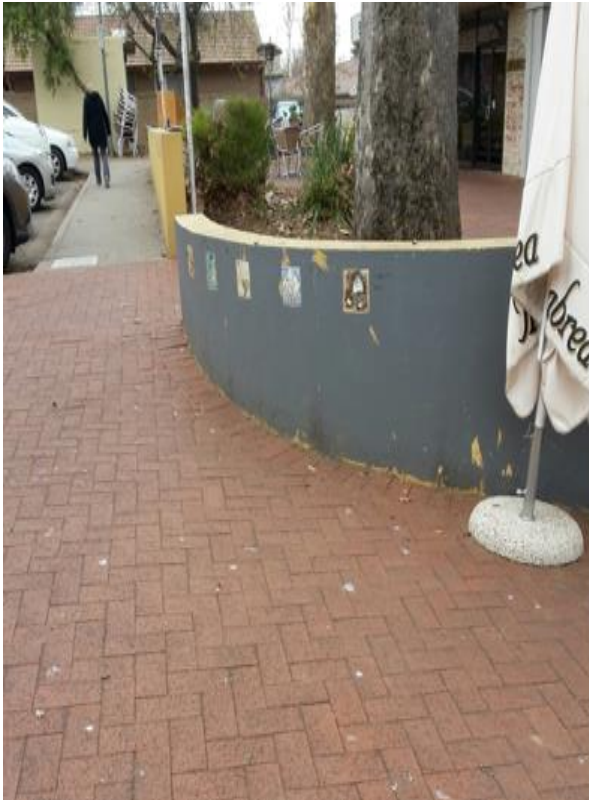
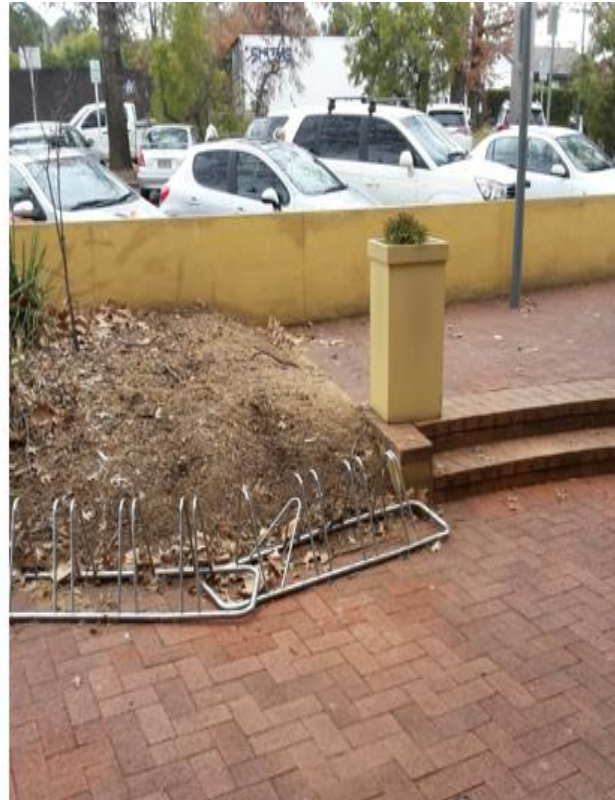
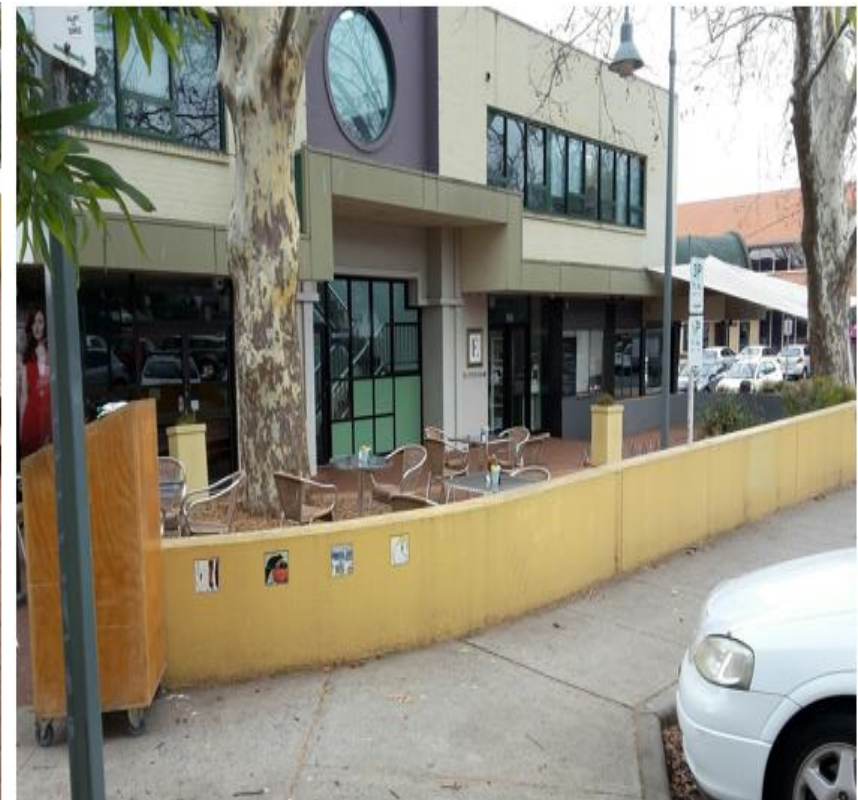
Walls chipped with badly damaged paintwork – Hutchins Street

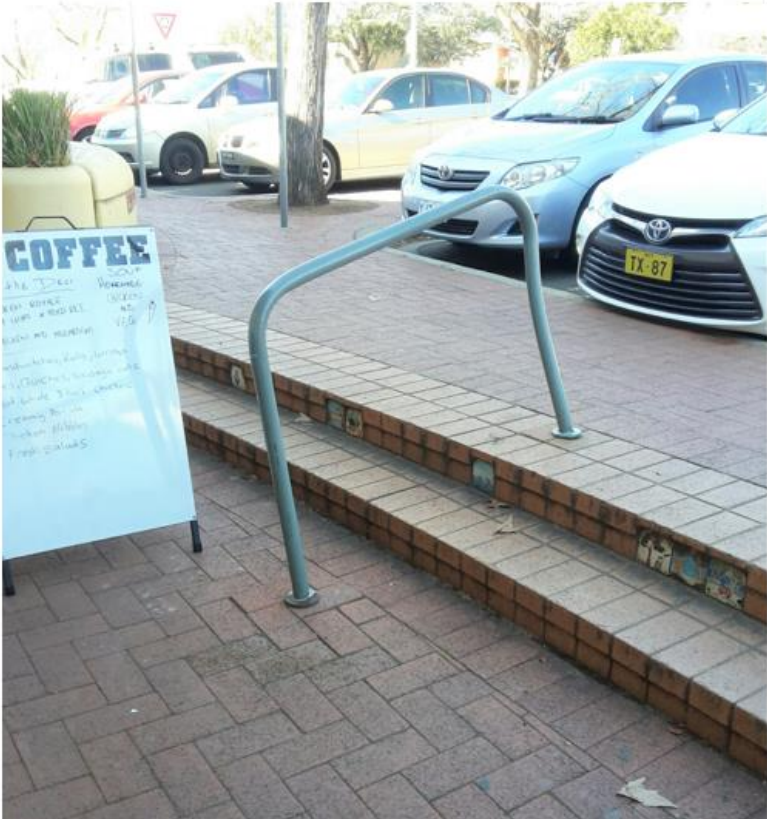
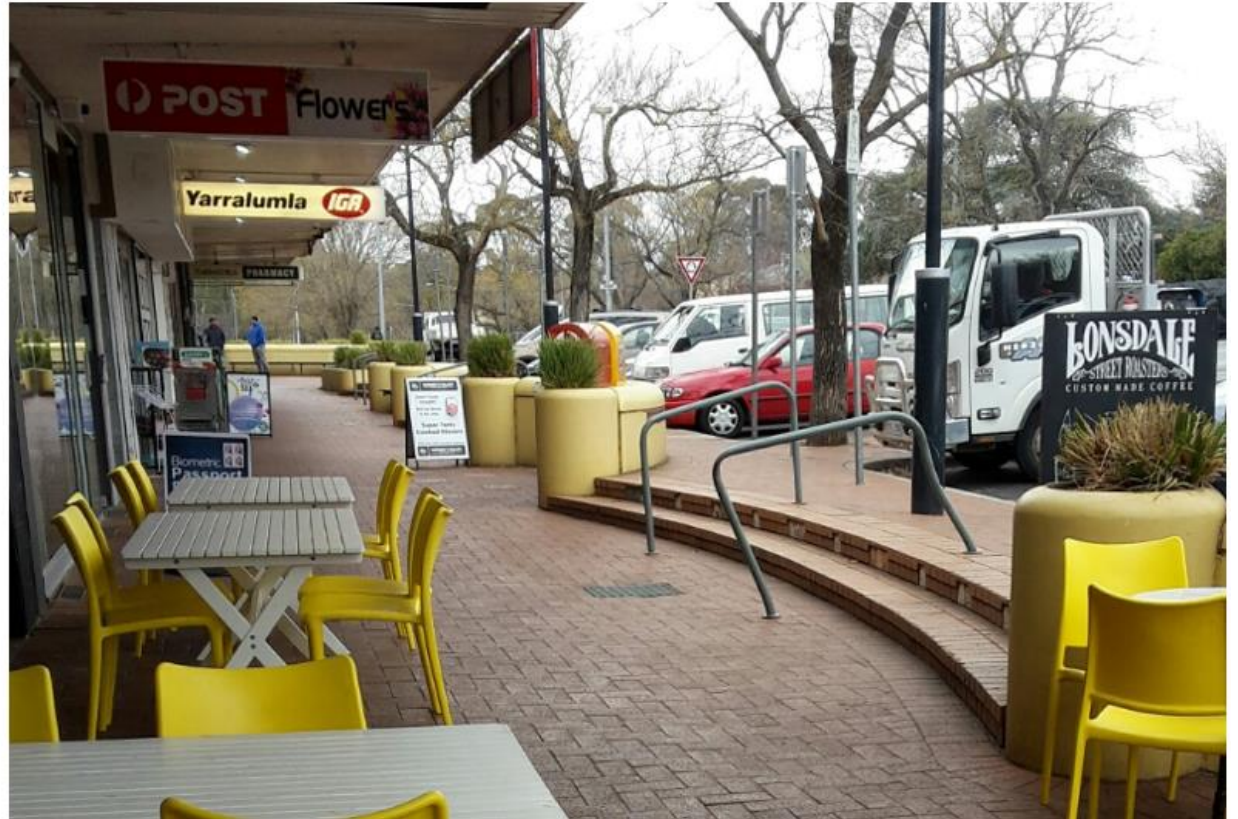
Two of the six handrails badly damaged – Bentham Street

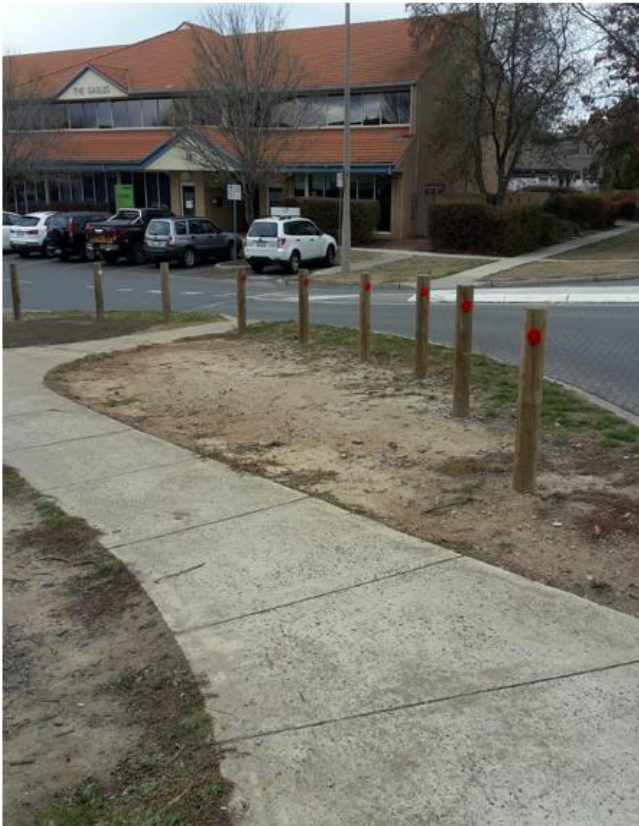
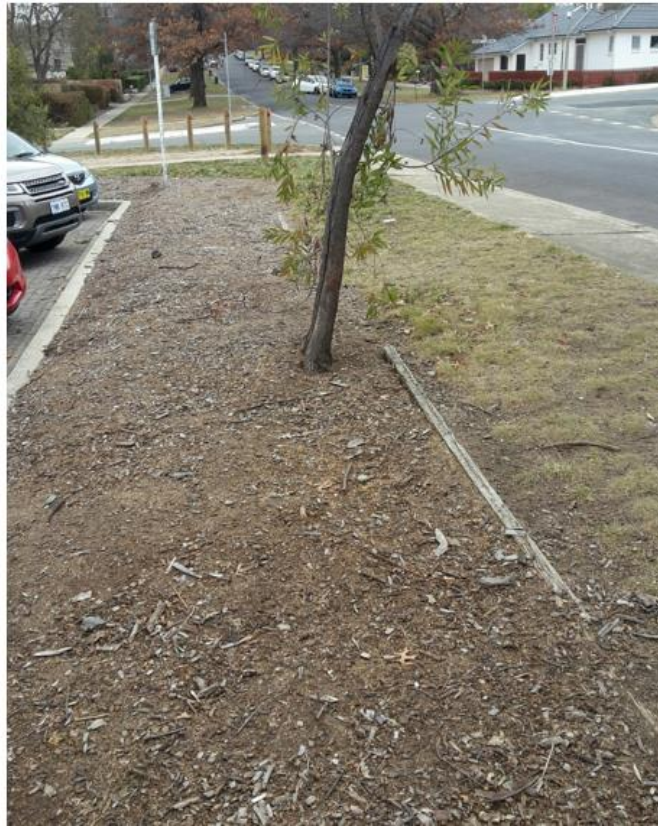
Bentham-Hutchins Street Garden Areas – many plants removed but not replaced

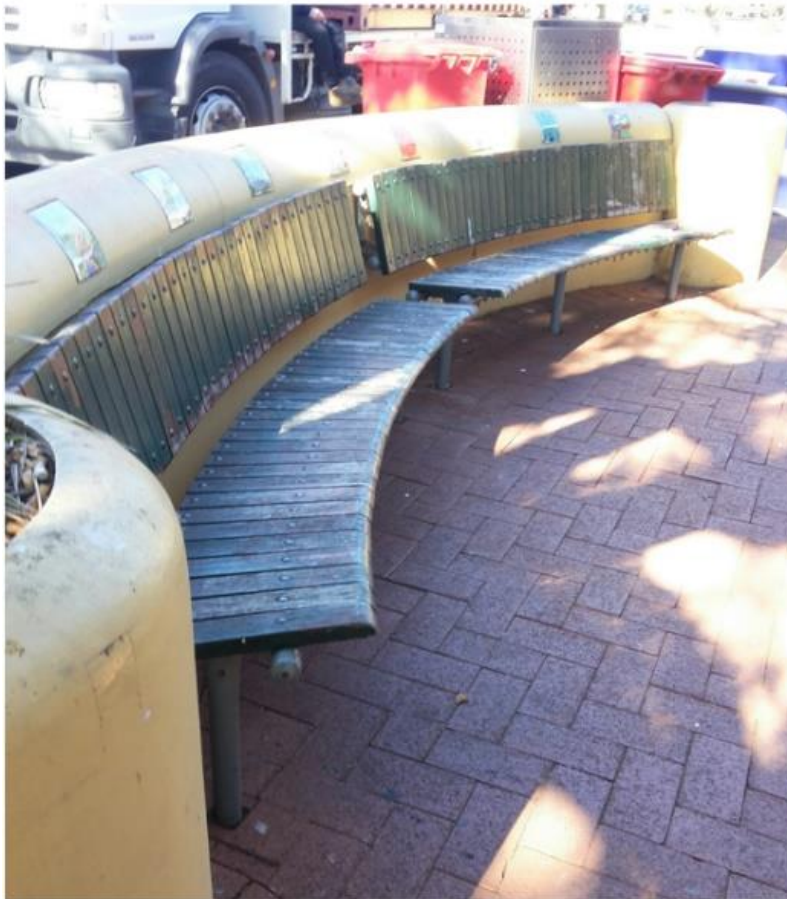
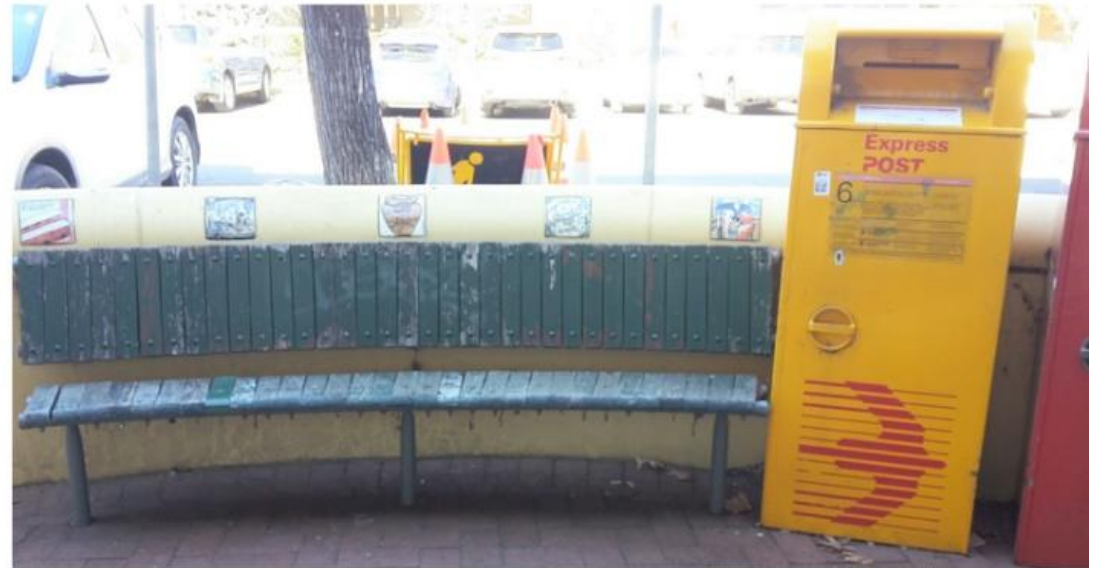
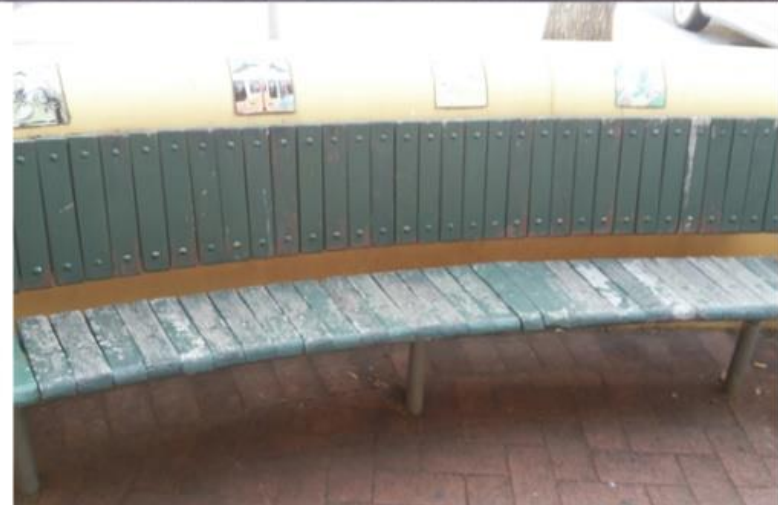
Wooden slatted public benches dangerous with rotten, eroded, splintering slats, paintwork gone – Bentham/Novar Street

- All the slatted wooden benches are in need of replacement. The many of the wooden slats are broken, rotten or very rough with exposed splinters. The slats have virtually no green paint left on them. The public risks injury from their use.

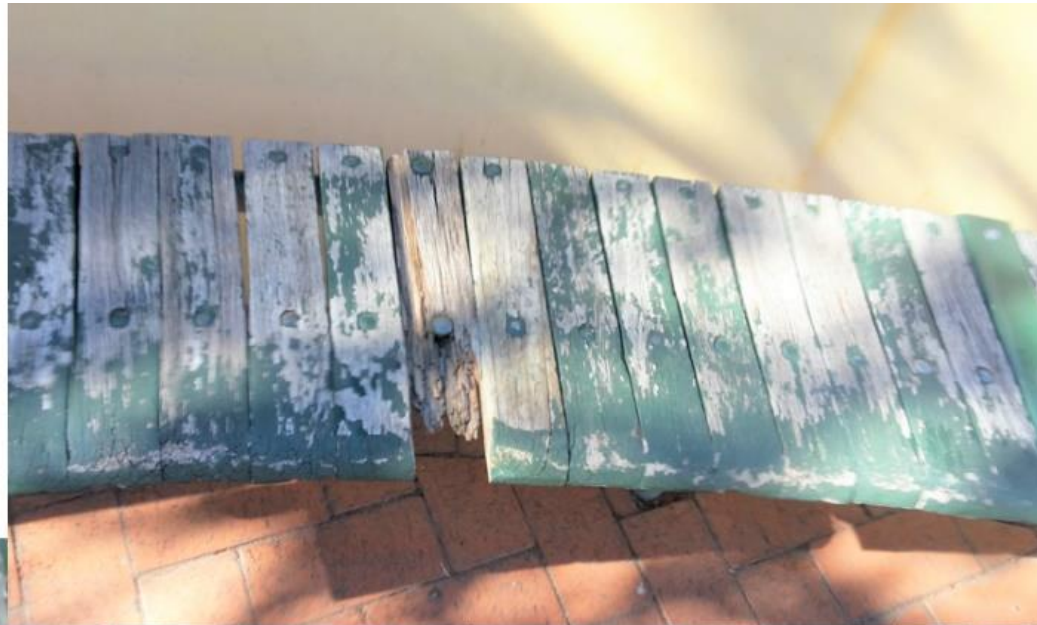
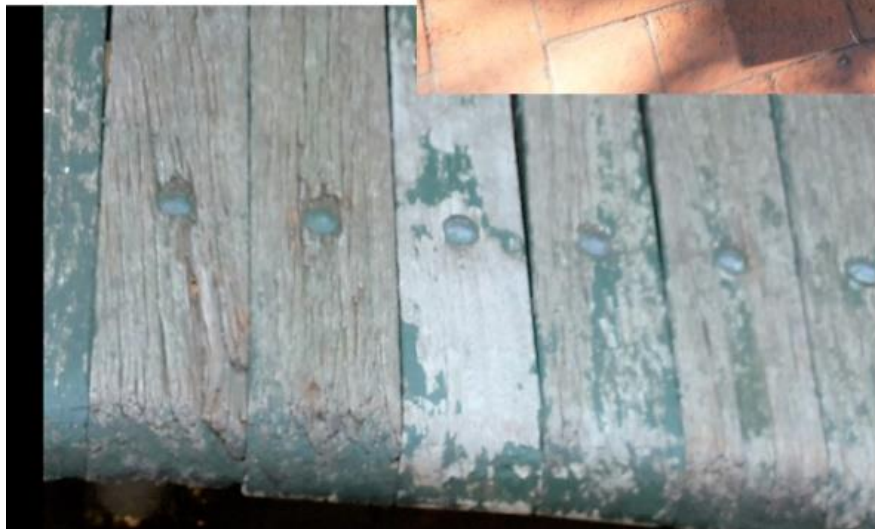
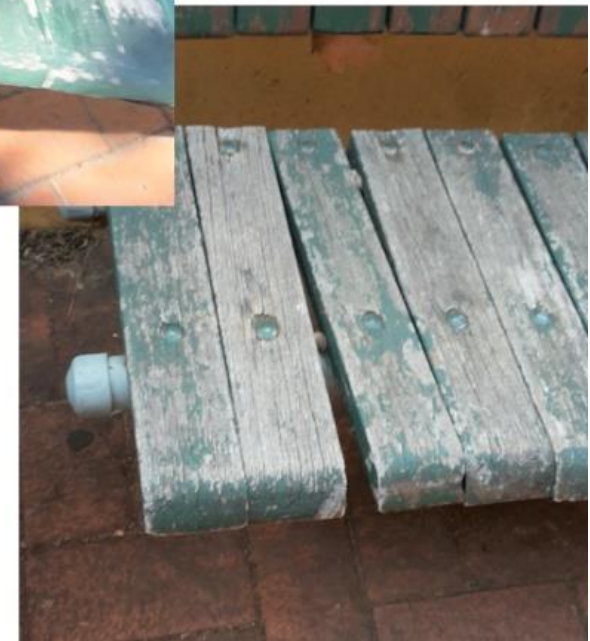
Wooden slatted public benches dangerous with rotten, eroded, splintering slats, paintwork gone – Bentham/Novar Street
